## **Appendix A12.2**

### Aquatic Ecology Baseline Report

Triturus Environmental Ltd. were contracted by Scott Cawley Ltd. to undertake an updated baseline aquatic and fisheries survey (2022) along numerous watercourses in the footprint of the proposed BusConnects Dublin – Core Bus Corridor Infrastructure Works project. The survey would provide more contemporary data over the initial aquatic surveys carried out for the project in 2020 given the time lapse since those surveys were conducted to support EIAR preparation for the project.

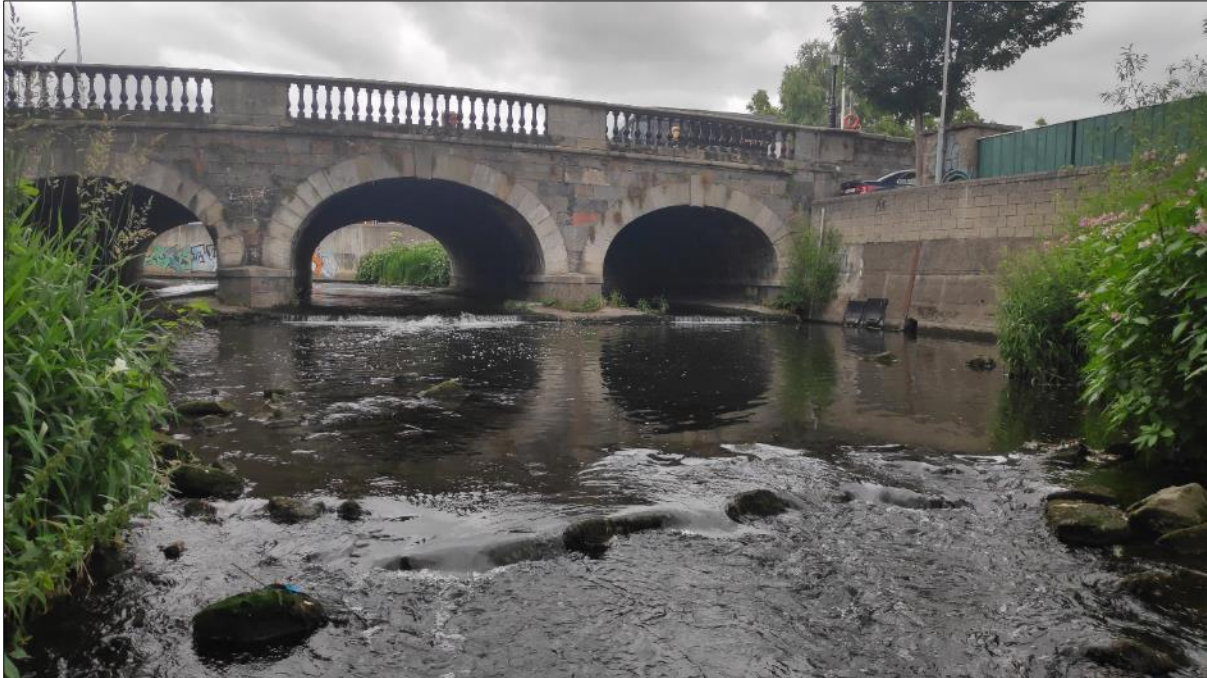
Site 1 was located on the River Tolka (EPA code: 09T01) at Frank Flood Bridge, Drumcondra. The river was a semi-natural lowland depositing watercourse (FW2) with a swift flow. Despite being located in a heavily urbanised area with high retaining walls, the river profile was surprisingly natural downstream of the bridge (upstream being glide dominated, held between retaining walls and with less natural character). The channel width was variable between 15m and 20m wide, being narrower downstream. The depth ranged from 0.3-1.2m. The river level was low at the time of survey (July 2022) and none of the 3 no. bridge arches were passable to fish (apart from European eel), i.e. c.0.3m fall from bridge apron. The profile was dominated by shallow fast glide and riffle with more localised pool (the largest of which was located immediately downstream of the bridge apron/weir). The riverbed comprised rendered concrete under the road crossing but downstream of the bridge the substrata were dominated by boulder and cobble with interstitial fine-medium gravels. The substrata were bedded but large pockets of well-sorted medium and coarse gravels were present at the pool tailing downstream of the bridge apron (weir). Siltation was moderate overall. Macrophytes were limited to occasional water mint (*Mentha aquatica*), bulrush (*Typha latifolia*) and watercress (*Nasturtium officinale*) along island margins, with rare blue water speedwell (*Veronica anagallis-aquatica*). The site supported a high cover of aquatic bryophytes, with frequent *Platyhypnidium riparoides* and occasional *Fontinalis antipyretica*. Filamentous algae was very high (>50% cover of *Cladophora* sp.), with discolouration and sewage fungus also recorded at an inflowing storm drain adjacent to the bridge apron (north bank). The riparian zone supported marginal stands of osier (*Salix viminalis*), grey willow (*Salix cinerea*) and crack willow (*Salix fragilis*) with abundant reed canary grass (*Phalaris arundinacea*) and abundant invasive Himalayan balsam (*Impatiens glandulifera*) on the north bank. Himalayan balsam coverage was noticeably higher than the previous October 2020 survey. Small gravel islands were colonised by reed canary grass with hedge bindweed (*Calystegia sepium*). Additionally, the invasive giant hogweed (*Heracleum mantegazzianum*) was present at the downstream end of the island/bar along the north bank of the river.

Downstream of the bridge, the river was considered a good brown trout nursery and good holding area for adult fish. Spawning for both salmonids and lamprey was considered locally good, despite siltation pressures and compaction of substrata. Upstream of the bridge, the river was mainly a holding area for salmonids with deeper glide habitat held between retaining walls. Lamprey ammocoete habitat was sparse given the high energy nature of the site. European eel habitat was good downstream of the bridge owing to ample boulder refugia and deeper pool areas. A stone loach (*Barbatula barbatula*) and juvenile flounder (*Platichthys flesus*) were recorded in the macro-invertebrate kick sample. White-clawed crayfish are not known from the River Tolka and none were recorded during the survey. A regular otter spraint site (2 sites, 4 spraints) was recorded on the edge of bridge apron under the Waterfront Apartments on the south bank immediately downstream of the bridge (ITM 716123, 736752).

**Plate 3.1** Representative image of site 1 on the River Tolka, facing upstream towards Frank Flood Bridge)

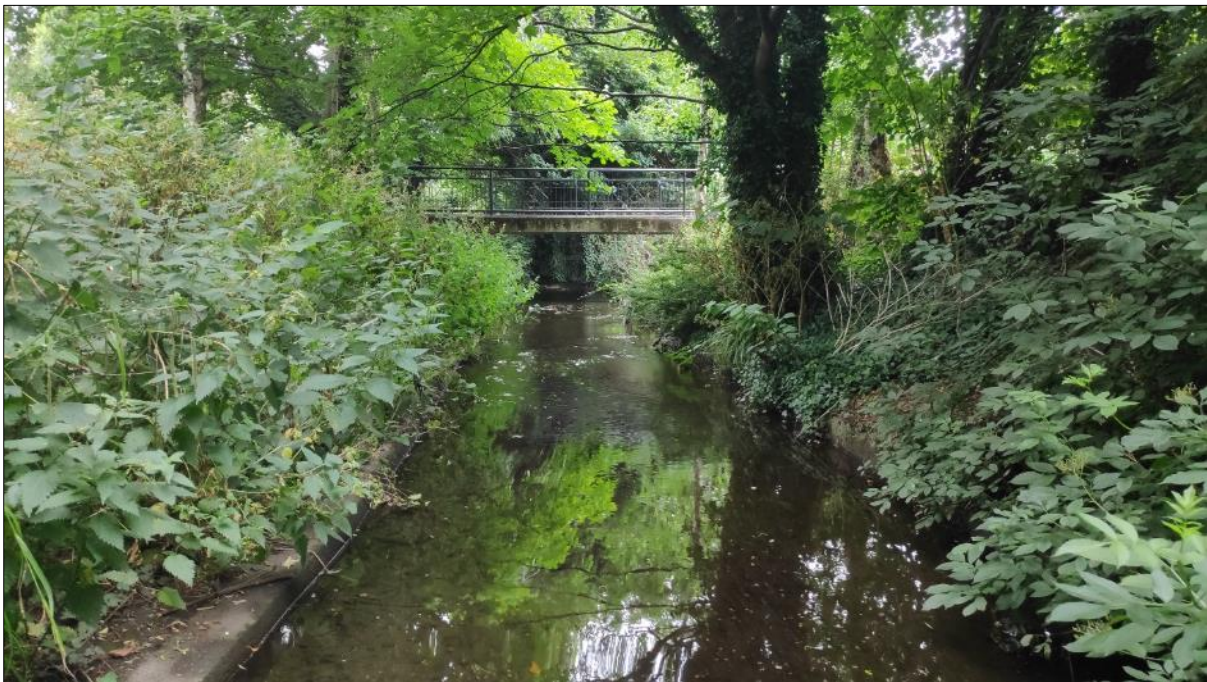
Site 3 was located at an existing footbridge on the River Poddle (09P03) at Mount Argus Park. Here, the watercourse was a very heavily modified channel with retaining walls on both banks (0.3m high). The river was swift flowing but a homogenous 0.05m depth at the time of survey with no variation in depth (no pool or deeper areas). The bed was rendered concrete (i.e. an open culvert) with only very localised superficial mixed gravels and small cobbles (<1% surface area). Given the artificial bed, macrophytes were absent. However, the moss *Rhynchostegium riparoides* was locally abundant growing on the concrete bed, typically in more shaded areas. Filamentous algae was abundant, indicating enrichment. The survey site was located immediately upstream of a small artificial pond (FL8). This pond also featured a 100% rendered concrete bed with depths from 0.1-0.3m. The river in the vicinity of the footbridge was heavily shaded by mature treelines of sycamore (*Acer pseudoplatanus*), ash (*Fraxinus excelsior*), willow (*Salix* sp.) and silver birch (*Betula pendula*) with

With the exception of three-spined stickleback (*Gasterosteus aculeatus*) (which were recorded via kick sampling and observed in the pond connected to the river), the River Poddle was of little to no fisheries value at this location given its very heavily modified, shallow nature, poor hydromorphology and known downstream barriers to migration (e.g. steep closed culvert downstream of the parkland). The river is also known to suffer from significant water quality issues which preclude the establishment and persistence of a healthy fish populations.

**Plate 3.3** Representative image of site 3 on the River Poddle in Mount Argus Park, facing upstream to the existing footbridge illustrating the heavily modified nature of the channel

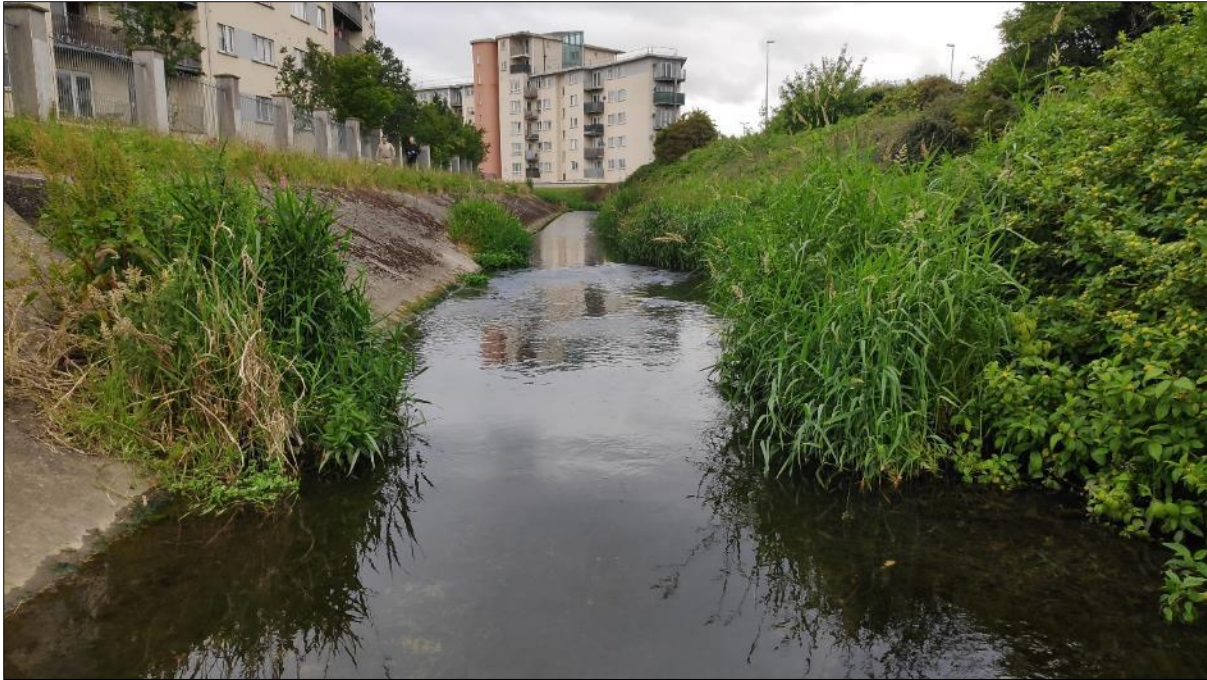
Site 4 was located on the River Camac (09C02) at Yellowmeadows near Clondalkin. The river was a lowland depositing watercourse (FW2) that had been historically straightened and heavily modified, with a retaining wall present along the south bank of the river (adjoining residential areas). The channel averaged 3-4m wide and 0.1-0.25m deep, with bankfull heights of 2-3m. Shallow fast glide predominated with occasional riffles and very limited small pool (to 0.5m). The channel featured an open masonry culvert in the vicinity of the survey site with only localised superficial accumulations of cobble and medium to coarse gravels. Small boulder were also present but localised with occasional sand. Siltation was moderate overall with some shallow accumulations in association with macrophyte beds. Instream macrophytes were rare given the concrete rendered riverbed. Lesser water parsnip (*Berula erecta*), fool's watercress (*Apium nodiflorum*), watercress and localised brooklime (*Veronica beccabunga*) were present in the margins. Cobble zones supported frequent spiked-water milfoil (*Myriophyllum spicatum*). Aquatic bryophytes were limited to occasional *Platyhypnidium riparoides*. Filamentous algal cover was high (30% cover) indicating enrichment. Numerous point sources were present locally, adjoining from the Nangor Road bank. The river margins were dominated by linear belts of reed canary grass with abundant nettle. The north bank was heavily scrubbed with primarily ornamental species like red osier dogwood (*Cornus sericea*) and *Cotoneaster* sp. with frequent invasive buddleja (*Buddleja davidii*), great willowherb and hedge bindweed. Downstream, a mature willow-dominated treeline was present along the river, with ash and sycamore. The site was bordered by parkland (WD5) to the south and artificial surfaces (BL3) to the north (Nangor Road).

Site 4 was of moderate value for salmonids only given its poor hydromorphology and shallow nature, with superior habitat both upstream and (especially) downstream. Spawning and nursery value was limited but nonetheless present (moderate value only). Holding habitat was good despite the lack of pool areas given the undercut banks/overhanging reed canary grass vegetation. White-clawed crayfish were present at a 'low' density >0 to <1 per 10 refugia; Peay, 2003). A total of  $n=2$  crayfish were recorded via sweep netting, with one adult and one hatchling recorded. Three-spined stickleback (*Gasterosteus aculeatus*) were visibly abundant. Lamprey ammocoete habitat was present very locally also but spawning habitat was poor (few finer gravels present given high flows rates and rendered bed). No otter signs were recorded during the site visit but the River Camac in the vicinity of the survey site is known to support otter (Macklin et al., 2019).

**Plate 3.4** Representative image of site 4 on the River Camac, facing upstream towards Áras Na Cluaine

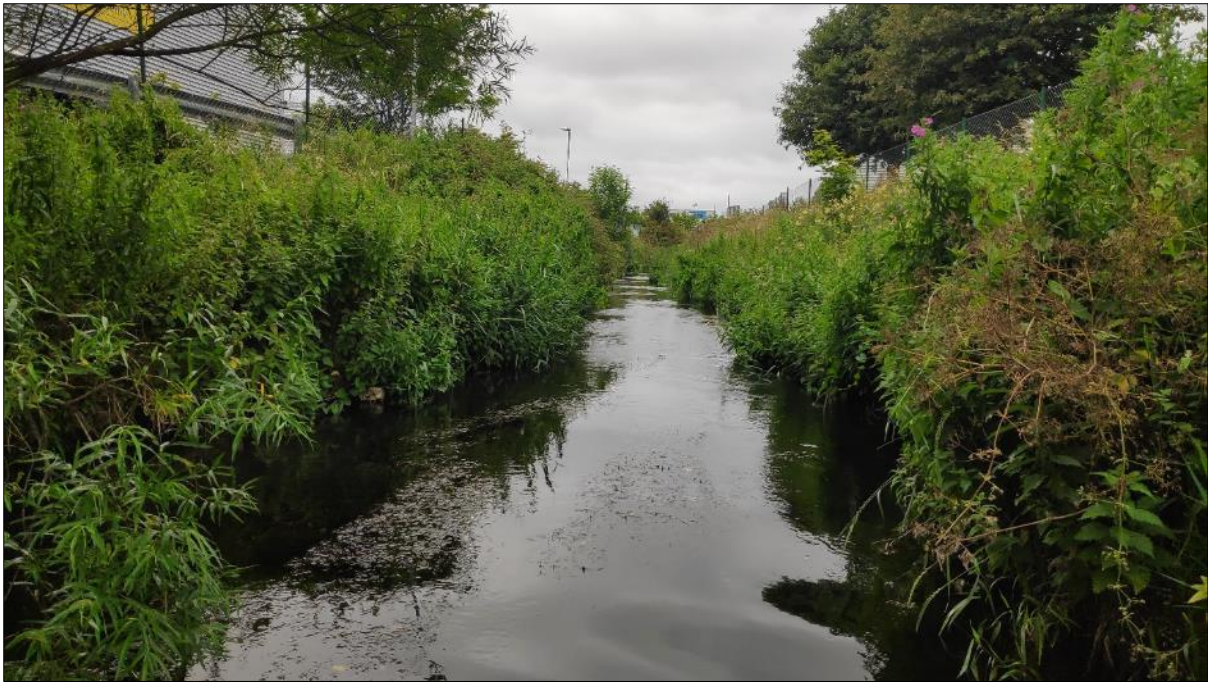
Site 5 was located on the River Camac (09C02) at the Nangor Road crossing (R134). The river was a lowland depositing watercourse (FW2) which had been historically straightened and modified upstream and downstream of the existing R134 road culvert (an extensive twin-bore corrugated pipe, 75m long). These culverts were passable to fish even at low summer flows. However, good recovery was evident instream, despite being surrounded by industrial/urban areas. Upstream of the culvert, the river averaged 3-4m wide and 0.5-1m deep with locally deeper glide and pools to 1m. The profile was dominated by deep glide with localised pool<sup>1</sup>. The substrata were dominated by relatively clean, unbedded/mobile fine to coarse gravels with low siltation (only light plumes underfoot). Cobble and small boulder was occasional (more prominent downstream of culvert). Silt beds were present marginally and in association with abundant growth of instream macrophytes. Downstream of the R134 culvert the river was 3m wide on average and 0.4-0.6m deep, with locally deeper pools to 0.8-1m. The flow was greater than upstream and fast glide predominated with occasional riffle areas and localised pools. Given the high flow rates, the substrata were dominated by cobble with occasional boulder. Medium to coarse gravels were frequent and present in small interstitial patches. Sand/silt accumulations were present in pool slacks near the culvert. Overall siltation was moderate. The substrata were relatively compacted (in contrast to upstream slower glide habitat). Macrophyte growth was dominated by abundant spiked water milfoil (50% cover) and frequent curled pondweed (*Potamogeton crispus*) with the margins and riparian slopes dominated by reed canary grass. Downstream, given high shading, instream macrophytes were limited to marginal watercress and

Site 4 offered some very good salmonid habitat (brown trout only given downstream barriers). Upstream of the culvert provided excellent quality spawning and nursery habitat (among the best on the entire river, pers. obs.) with very good holding habitat for abundant adult trout in undercut banks/under overhanging reed canary grass. Downstream, whilst spawning and nursery value was somewhat reduced, adult holding habitat was very good given undercut banks and prominent submerged tree roots (willow and sycamore). These also offered excellent refugia for white-clawed crayfish, which were recorded at 'very high' densities (>5 per 10 refugia; Peay, 2003). A total of  $n=25$  crayfish were recorded from 30 refugia via sweep netting, with males, females and juveniles present, ranging from 18-38mm carapace length. The culverts also provided high quality crayfish habitat given an abundance of cobble and boulder. Lamprey ammocoete habitat was present both upstream and downstream of the culvert, usually in association with instream macrophyte beds. European eel habitat was good throughout but better upstream. Two otter spraint sites were recorded under the southern culvert on instream trash/debris (both were old and contained crayfish remains, ITM 708589, 732063 & 708572, 732050).

**Plate 3.5** Representative image of site 5 on the River Camac, facing upstream from culverts

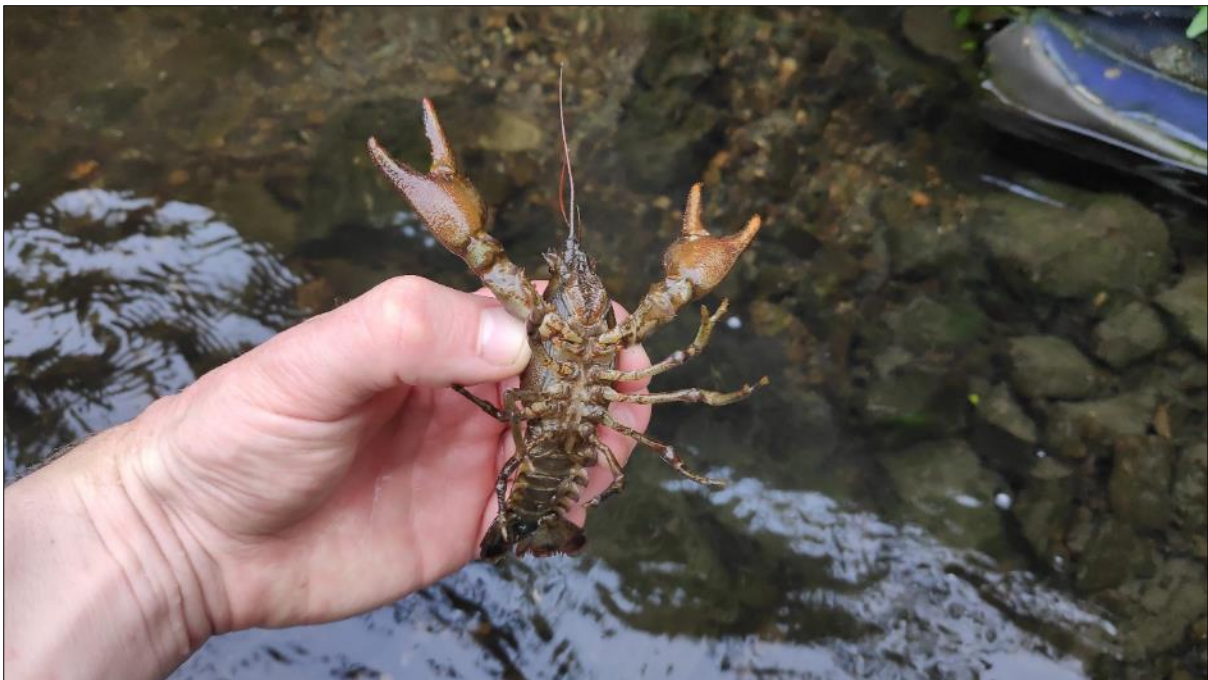
**Plate 3.6** One of many white-clawed crayfish recorded from site 5 via hand searching in July 2022

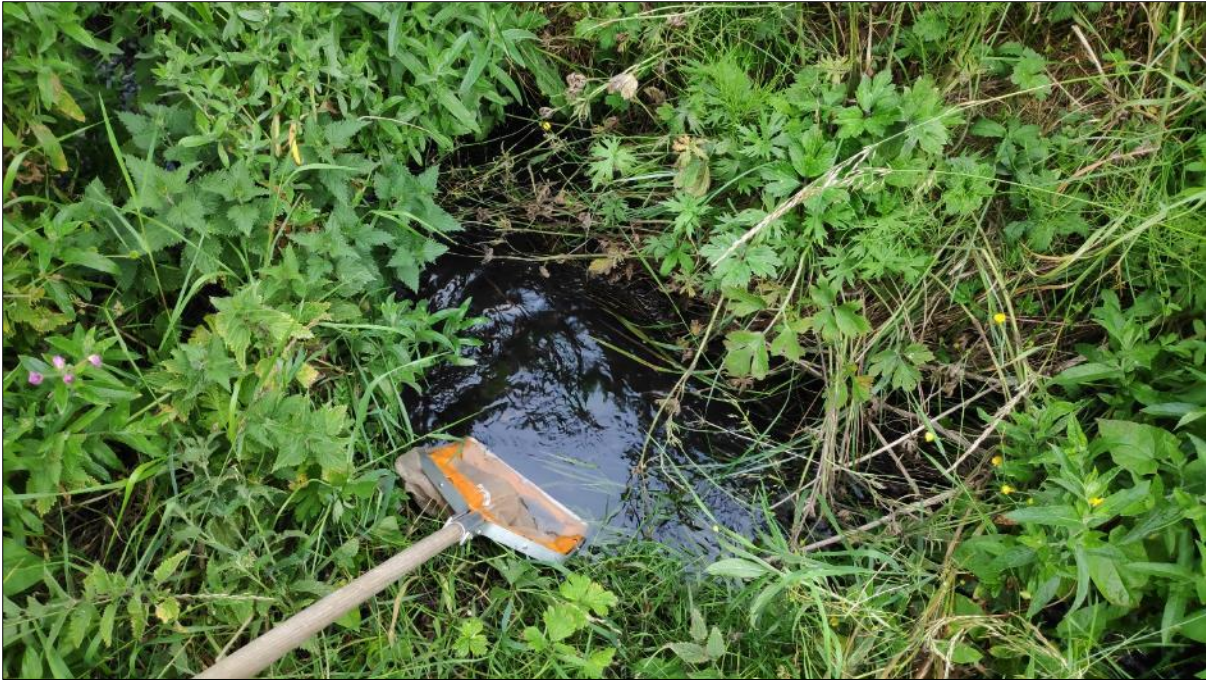
Site 6 was located on the upper reaches of the River Poddle (09P03) where it emanated from a long underground culvert adjacent to the Greenhills Road and Bancroft Park. The river at this location represented a small, lowland depositing watercourse (FW2) that had been historically straightened and deepened, (a two-stage channel was evident). The river averaged  $\leq 1\text{m}$  wide and 0.1-0.2m deep in a deep U-shaped channel with 2-3m bankfull heights. Shallow glide predominated with occasional riffle zones and localised small pool. The substrata were dominated by cobble and small boulder which were heavily silted and compacted. Some medium to coarse gravels were present interstitially. Siltation was high overall although sediment accumulations were largely absent at the swift flowing site. Hydrocarbon plumes were evident underfoot on disturbance of sediment during Q sampling. Natural bank erosion (scouring) was evident in the narrow channel and was contributing to siltation, in addition to surface water run-off from adjoining hard standing areas (BL3). The river was heavily tunnelled by scrub and herbaceous vegetation which resulted in a lack of macrophyte growth. Filamentous algal cover was high in all open areas (>50% cover), indicating heavy enrichment. The riparian areas supported abundant nitrophilous species such as great willowherb, nettle and hedge bindweed. Other riparian species included meadowsweet, meadow buttercup (*Ranunculus acris*), common knapweed (*Centaurea nigra*), gorse (*Ulex europaeus*), ragwort (*Jacobaea vulgaris*) and rank grasses. Very dense bramble scrub was present in the vicinity of the road culvert. The site was bordered by dry meadows (GS2) and scattered trees and parkland habitat (WD5) with ornamental hedging.

With the exception of three-spined stickleback, the River Poddle at site 6 was of little to no fisheries value given water quality issues (including very heavy siltation) poor hydromorphology and known downstream barriers to migration. The river is also known to suffer from significant water quality issues which preclude the establishment and persistence of a healthy fish populations. No white-clawed crayfish were recorded and none were known from river. The site was not of value to otter.

**Plate 3.7** Representative image of site 6 on the upper reaches of the River Poddle

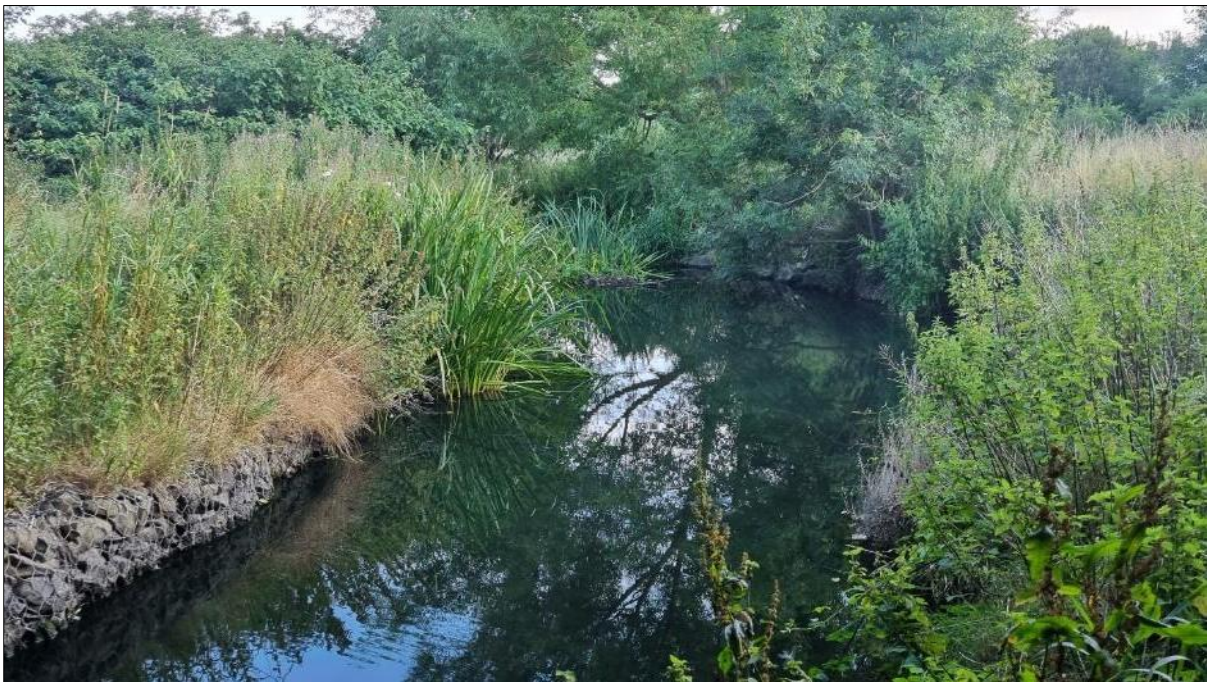
Site 7 was located on the River Tolka (09T01) downstream of the N3 road culvert. The lowland depositing watercourse (FW2) had been deepened and heavily modified historically, with bank reinforcements (boulder revetment) present downstream. The river averaged 4-5m wide and 0.2-0.8m deep, with locally deeper pool to 1.3m. The profile comprised deep slow-flowing glide with localised deep pool and riffle near the meander downstream of the culvert. The riverbed featured a rendered concrete apron under the road crossing. The substrata were dominated by cobble with mixed gravels and silt accumulations. The substrata were typically very heavily bedded and silted, with localised mobile gravels present downstream of the survey site. The site supported limited macrophyte growth, with occasional branched bur-reed (*Sparganium erectum*) and very localised water crowfoot (*Ranunculus* sp.) and common water starwort (*Callitriche stagnalis*). Cobble substrata supported heavy cover of *Fontinalis antipyretica* with abundant filamentous algae (*Phormidium* sp. and *Cladophora glomerata*) indicating significant enrichment. The riparian areas were heavily scrubbed with dense bramble, ornamental dogwood (*Cornus* sp.), great willowherb, nettle, hogweed and colt's-foot (*Tussilago farfara*). The riparian areas also supported scattered mature sycamore, osier (*Salix viminalis*) and crack willow (*Salix x fragilis* agg.).

Site 7 was of moderate value for salmonids only given evident water quality pressures, chiefly siltation. The river at this location was considered a moderate quality brown trout nursery, with some localised deeper pools (including immediately downstream of the culvert) providing some good, although localised, holding habitat. The quality of spawning habitat for salmonids and lamprey was significantly compromised by siltation and high coverage of filamentous algae. However, some improved spawning habitat for both salmonids and lamprey was present >100m downstream of the culvert (but was absent elsewhere). The site offered poor lamprey ammocoete habitat given the high flow rates and predominance of hard substrata. The site was of moderate value to European eel although bedding of

**Plate 3.8** Representative image of site 7 on the River Tolka, facing downstream to meander from N3 culvert

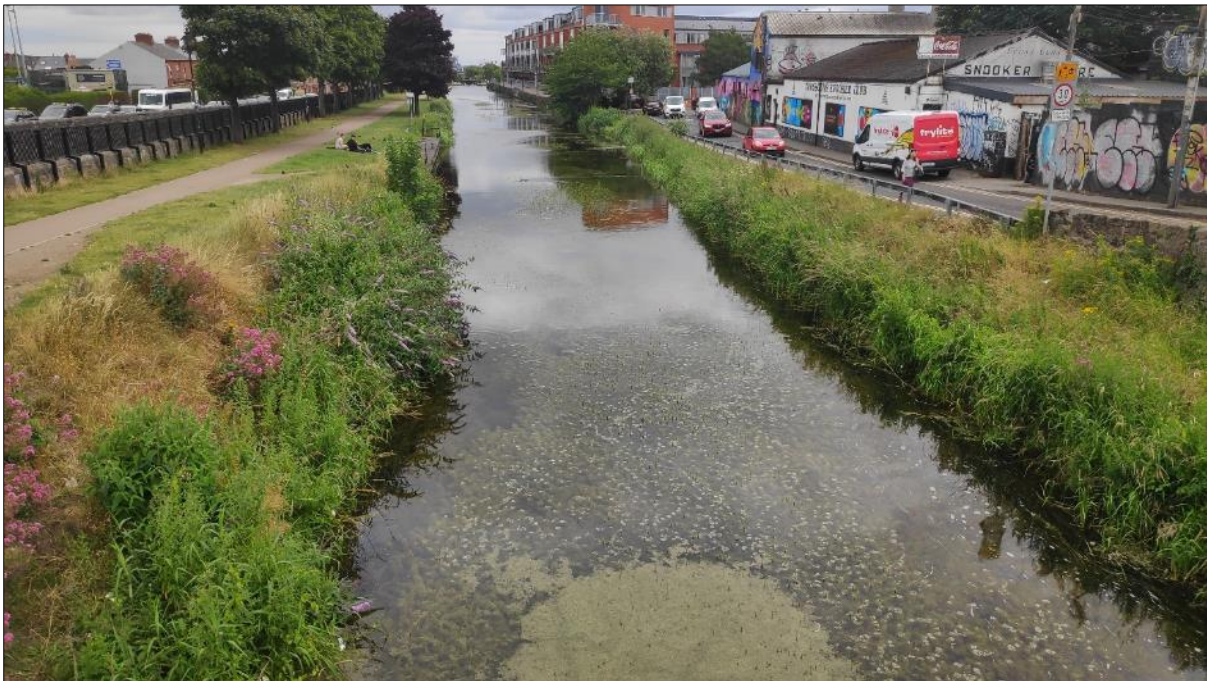
The Royal Canal between the 4<sup>th</sup> and 5<sup>th</sup> lock (level 4, Phibsborough) was a uniform 10-12m wide and 1.5-2.5m deep, with a centrally deeper navigation channel in most areas. The substrata were dominated by silt with high clay fractions (often >0.3m in depth), with scattered boulder and localised marginal cobble/gravel areas. Instream, the macrophyte community was dominated by whorled watermilfoil with frequent heterophyllus yellow lily. Ivy-leaved duckweed (*Lemna trisulca*) was abundant. Canadian pondweed (*Elodea canadensis*), Nuttall's pondweed (*Elodea nuttallii*) and stonewort (*Chara* sp.) were all frequent. Amphibious bistort (*Persicaria amphibia*) was occasional along the canal margins. The rare and protected opposite-leaved pondweed (*Groenlandia densa*) is known from this area of the Royal Canal (BEC, 2011; NPWS data) but no stands were observed during the survey (July 2022). The lock structures were covered by the generalist moss species *Fontinalis antipyretica* and *Rhychostegium riparoides* a species common in alkaline waters. The canal margins were lined by narrow linear strips (FS1) dominated by reed sweet grass with frequent stands of iris

**Plate 3.9** Representative image of site 8 on the Royal Canal at Phibsborough, facing downstream from Cross Guns Bridge to the 4<sup>th</sup> lock
